## River Bank Instability Detection and Monitoring Assessment

One principal cause of river bank collapse is the removal of more sediment from stream banks than the system can replenish. This study aims to assess the river bank erosion rate and erosion monitoring assessment for about 3 km of the Shelie River. The primary data (more than 20 river banks and 20 bed materials, as well as 104 river cross-sections) were collected using standard surveying equipment. Sieve and hydrometer analyses were implemented. Secondary (metrological) data were collected from an Ethiopian national metrological agency. The HEC-RAS model was used to compute the water surface profile and discharge-stage analysis. Additionally, the BSTEM model was used to depict the river bank migration rate and its stability analysis. BSTEM model result showed that left river banks are retreating laterally on average 0.012 m/hr for the considered reach, and the overall safety factor is greater than unity. Further, steady state flow simulation results confirmed that the conveyance capacity of the considered reach is not enough to carry a 50-year return period design discharge, and flood inundation raises a maximum of 1.2 m

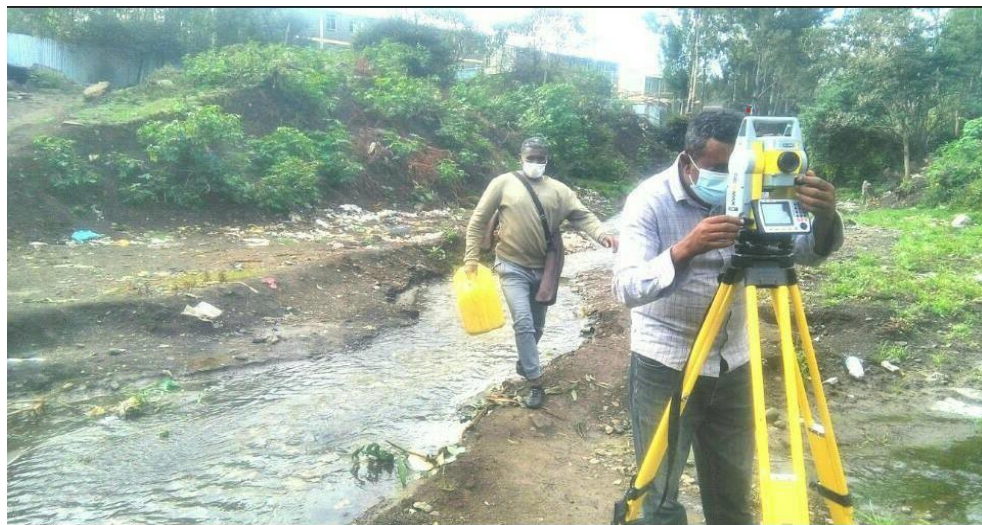
Figure 4. River survey data collection March; 2024.

laid out normal to the direction of flow at specified intervals measured along the center line of the main channel as shown (Fig. 4). The cross-section surveys were collected for a minimum of 20 m and a maximum of 30 m intervals between each cross-section for a 3 km reach length below.

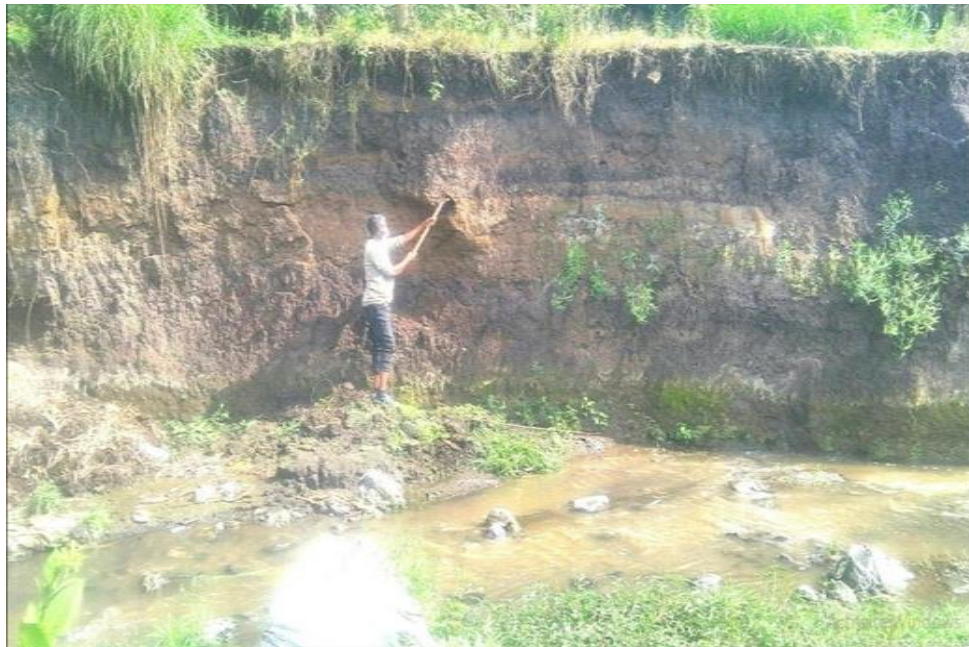
**Figure. 5:** Sample survey in April 2024

reaches for a 3 km reach length. Representative bed and bank samples were taken from the center, left, and proper channels and mixed (Figs. 5 & 6 below). Similarly, the representative bank materials were taken at the top, middle, and bottom and mixed. Both samples were collected in April 2024 and brought to the Woldia University soil laboratory, where sieving and hydrometric methods were used.

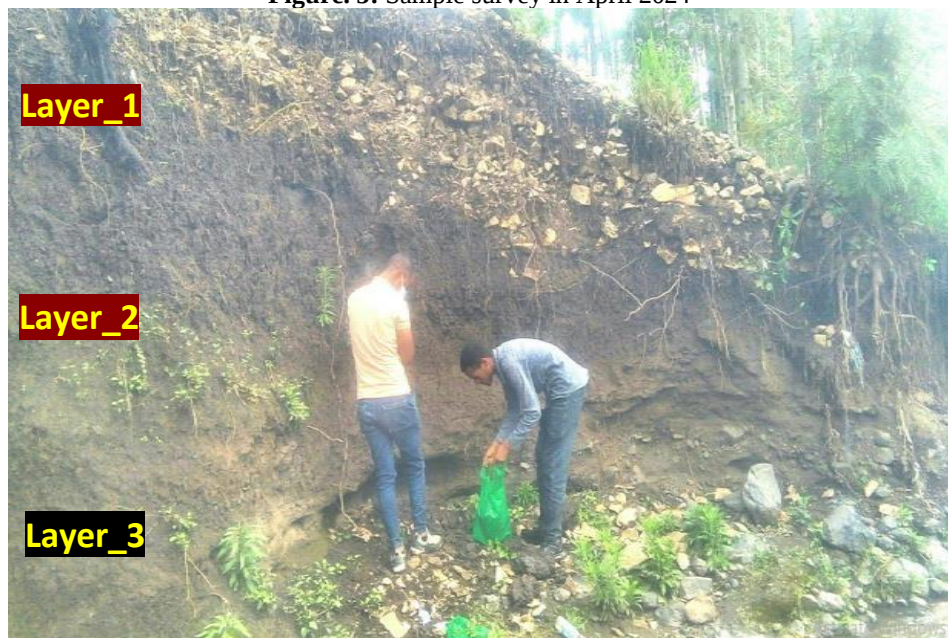
**Figure 6.** Sample survey in April 2024.

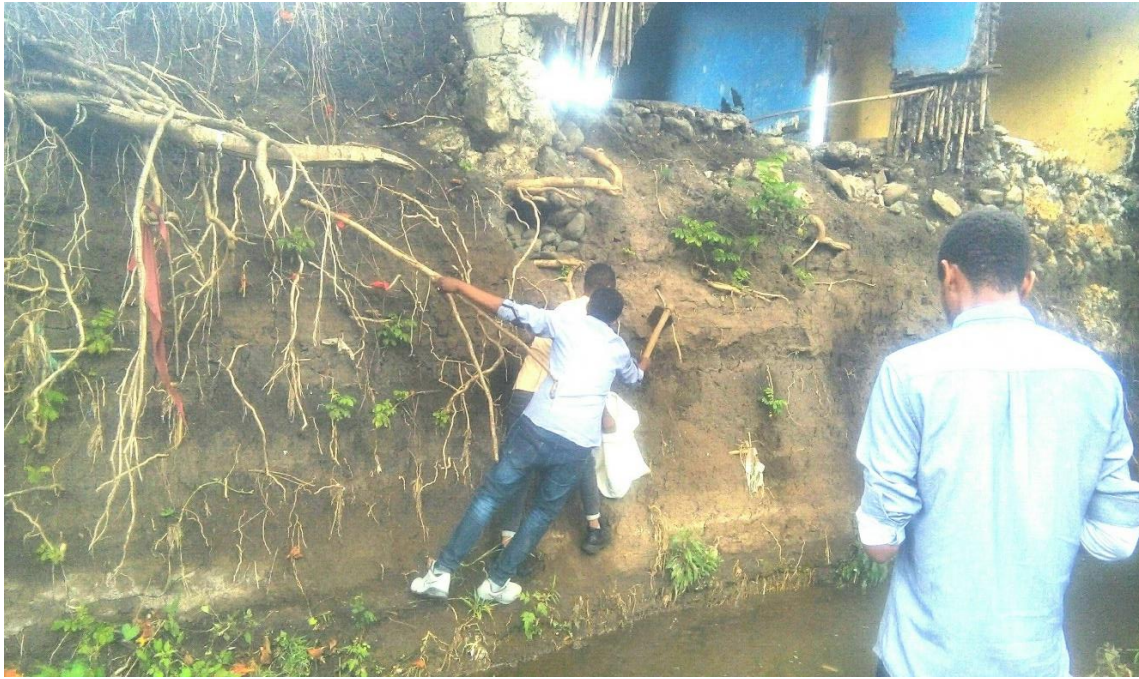
**Figure 16.** Unconsolidated and non-cohesive bank materials at the lower reach.
