## River Bank Instability Detection and Monitoring Assessment

River  
Bank erosion  
BSTEM  
HEC-RAS  
Flood

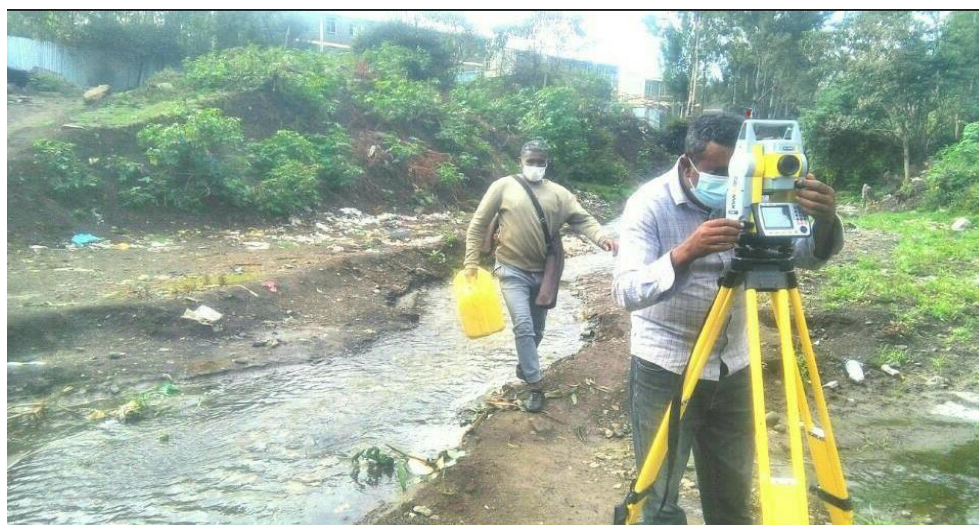
Figure 4. River survey data collection March; 2024.

laid out normal to the direction of flow at specified intervals measured along the center line of the main channel as shown (Fig. 4). The cross-section surveys were collected for a minimum of 20 m and a maximum of 30 m intervals between each cross-section for a 3 km reach length below.

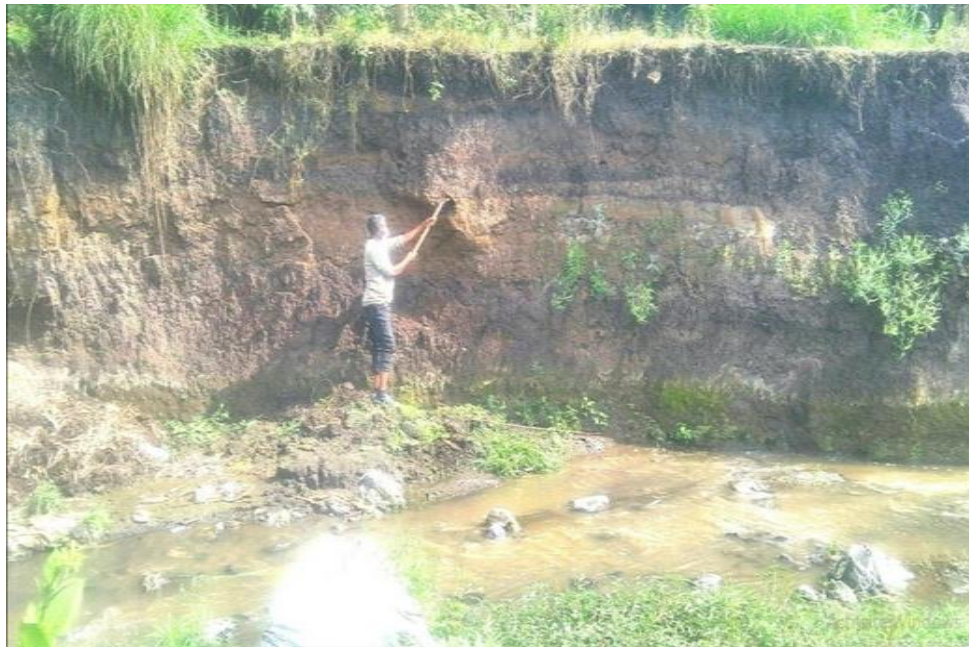
**Figure. 5:** Sample survey in April 2024

reaches for a 3 km reach length. Representative bed and bank samples were taken from the center, left, and proper channels and mixed (Figs. 5 & 6 below). Similarly, the representative bank materials were taken at the top, middle, and bottom and mixed. Both samples were collected in April 2024 and brought to the Woldia University soil laboratory, where sieving and hydrometric methods were used.

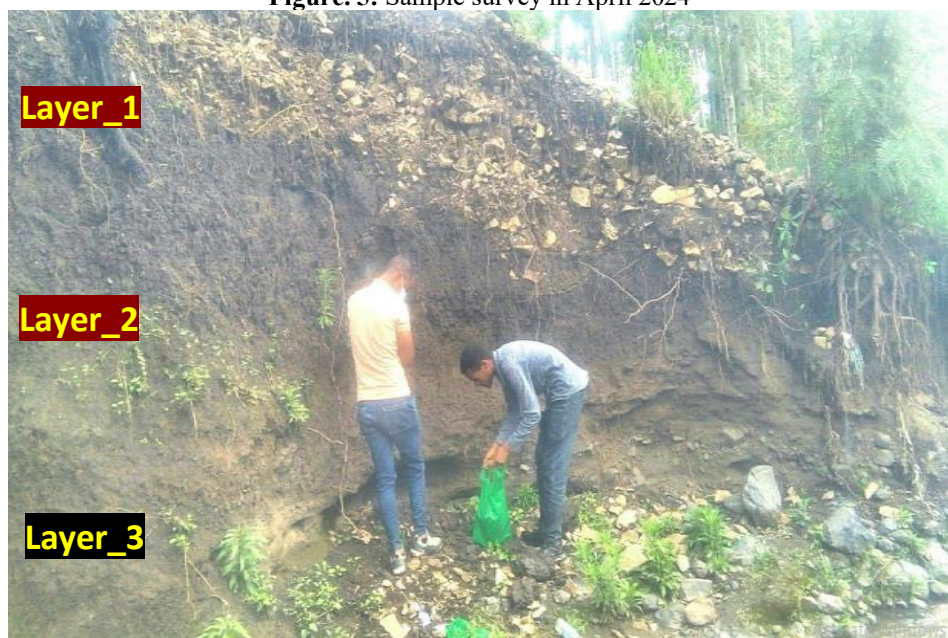
**Figure 6.** Sample survey in April 2024.

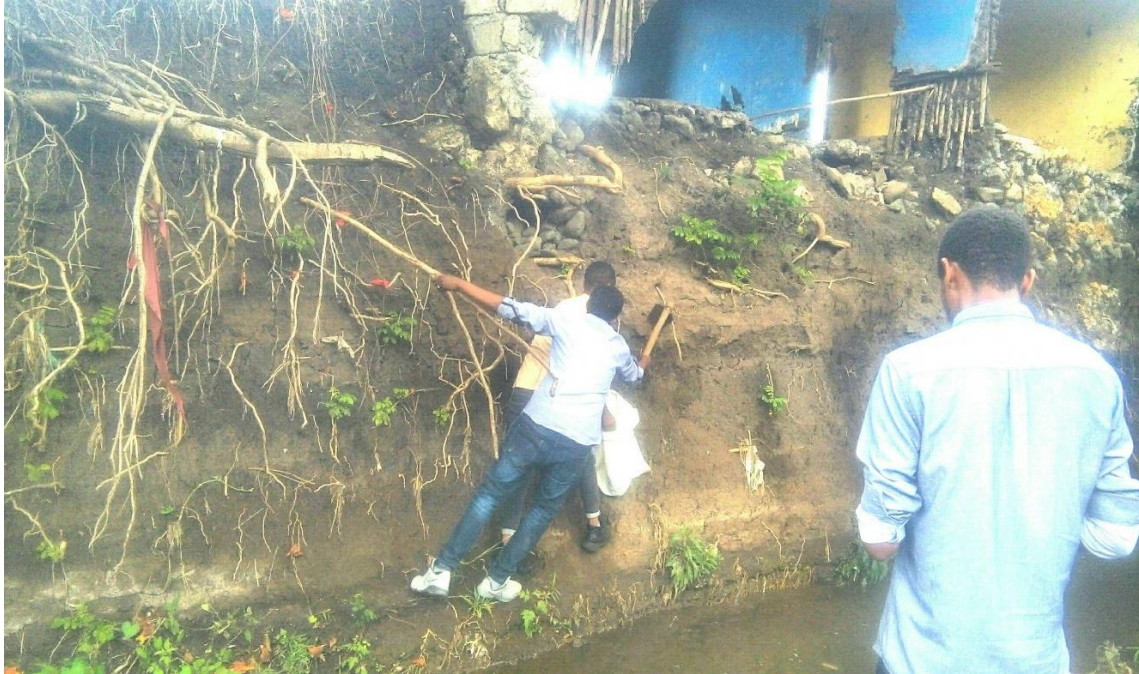
**Figure 16.** Unconsolidated and non-cohesive bank materials at the lower reach.

unstable, with a factor of safety less than unity, because the river system seeps through cracks in the soil, thereby wetting the stream bank materials and making them more prone to failure. As shown in Table 3 below, the total eroded area from the bank, bank toe, and bed was estimated to be 0.383 m<sup>2</sup>, 2.644 m<sup>2</sup>, and 2.448 m<sup>2</sup>, respectively. The findings suggest. Overall, this analysis not only provides critical insights into the dynamics of river bank stability but also serves as a foundation for targeted interventions to preserve valuable river ecosystems and protect adjacent properties from erosion.
